**Flood Control Project Maintenance  
Levee Inspections**

**Fall 2019 Levee Maintenance Deficiency Summary Report**

**Sacramento River Basin**

**Lake County Watershed Protection District**

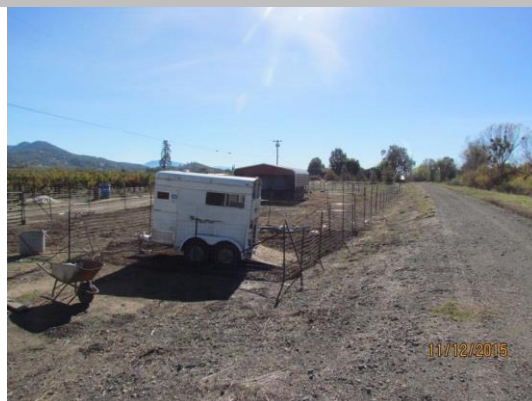
Photo 1 of 1 : FA\_2019\_NA0009\_3\_24\_20190904\_00012.jpg

LM Start	0.14	Rating **	M	Issue No.	24
LM End	0.18	Issue Type +	En	Location *	LS
Category	Earthen Levee			GPS Latitude/Longitude	
				Start	End
Item	Encroachments			39.188465 °	39.187905 °
				-122.907687 °	-122.907817 °
DWR ID	DWR_NA0009_01_f_2019_24				
Comment Code					
FE : Fence					
Inspector Comment					
The landowner needs to move the fence outside of the levee R/W line, which is 5' landward of the levee toe per As-builts CC-4-4-29.

View of the fence along the landside toe.

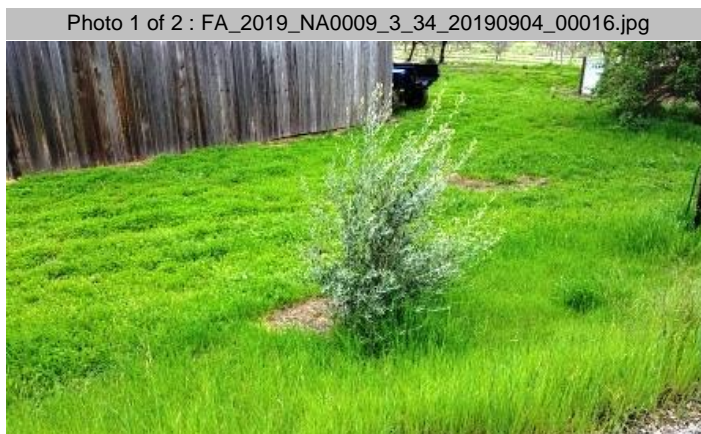
LM Start	0.30	Rating **	M	Issue No.	34
LM End	0.30	Issue Type +	En	Location *	LS
Category	Earthen Levee			GPS Latitude/Longitude	
				Start	End
Item	Encroachments			39.186306 °	39.186306 °
				-122.908376 °	-122.908376 °
DWR ID	DWR_NA0009_01_s_2019_34				
Comment Code					
CR : Crops					
Inspector Comment					
Landowner needs to remove newly planted trees from the levee toe easement.

View of newly planted trees within landside toe easement. Spring 2019

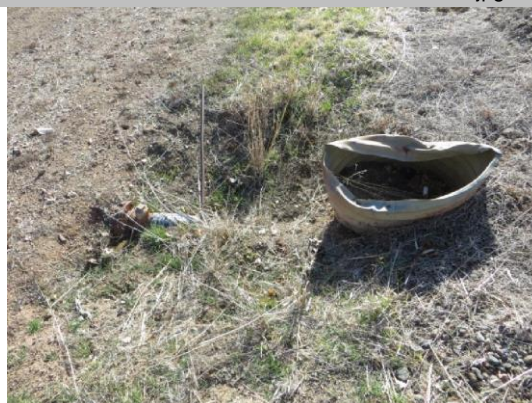
Photo 1 of 3 : UCIP\_FA\_2019\_55696\_49782.jpg

Comment Code					
Inspector Comment					
DS_ID:21193 FS_ID:55696 EP_NO: 5237 Repair Type: Non-Urgent Crossing Status: Found UCIP Comments: 10/16/2019 Record remains Non-Urgent; crossing has been abandoned. Owner will need to coordinate with CVFPB to remove or abandon crossing per Title 23 requirements. The UCIP inspection was completed with DWR Inspector, L. Dial, and LMA representative, S. Webb. (O. Magana - DWR UCIP)01/09/2014 Pipe appears abandoned and should be done so properly. (W. Wylie - DWR UCIP) FIELD_STRUCT_DESC: *ABANDONED* 6-inch coated steel irrigation pipe possibly sleeved through an 8-inch steel pipe, 3 feet below the crown. Siphon breaker in 24-inch corrugated metal riser unit on the landside (LS) slope. Reinforced concrete cutoff wall at center of levee. Butterfly valve on the waterside (WS) at pump on concrete base on the WS bank. Pole on the WS berm with overhead power line supplying electricity to the pump. (Installed under Permit No. 5237, 1966 - Moitozo Brothers, Inc.). [Additional Reference(s): DWR Levee Log, 2005. USACE Sacramento O&M Manual 506.2, August 1961, (HLM 0.54), Station M296+75, 8-inch pipe, dwg no. CC-4-4-29, Index Sheet 6: page 6, 40 of 64]. FS Date: 10/16/2019 3:57:00 PM

Pipe and siphon breaker visible on LS slope.

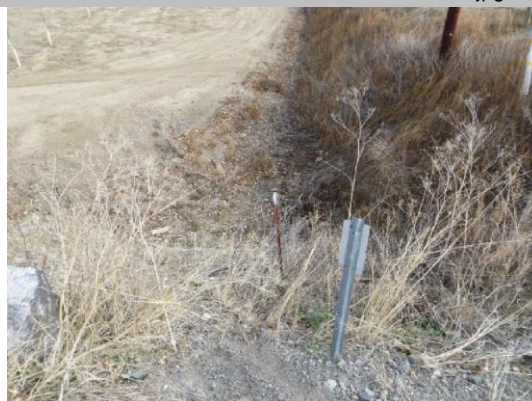
Photo 1 of 3 : UCIP\_FA\_2019\_55693\_49785.jpg

Comment Code					
Inspector Comment					
DS_ID:21194 FS_ID:55693 EP_NO: 11468 Repair Type: Non-Urgent Crossing Status: Found UCIP Comments: 10/16/2019 Record has been updated from No Action Needed to Non-Urgent; need to audit record to confirm owner. Crossing has been internally inspected under the DWR DMP Phase 1 project. Inspection report is still not available. The UCIP inspection was completed with DWR Inspector, L. Dial, and LMA representative, S. Webb. (O. Magana - DWR UCIP) FIELD_STRUCT_DESC: 24-inch corrugated metal drainage pipe through the levee, 8 feet below the crown. Flap gate on the waterside (WS) end. Concrete headwalls on both ends. (Pipe retained through the levee under Automatic Board Order (ABO) issued as Permit No. 11468, 1975 - Moitozo Brothers, Inc.). [Additional Reference(s): DWR Levee Log, 2005. USACE Sacramento O&M Manual 506.2, August 1961, Station M293+50, 24-inch pipe, dwg no. CC-4-4-29, Index Sheet 6: page 6, 40 of 64]. FS Date: 10/16/2019 3:58:00 PM

Drain pipe visible at concrete headwall on LS toe.

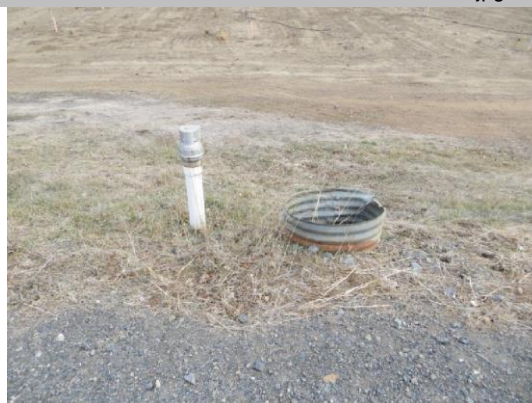
Photo 1 of 3 : UCIP\_FA\_2019\_55697\_49789.jpg

Comment Code					
Inspector Comment					
DS_ID:21196 FS_ID:55697 EP_NO: N/A Repair Type: Non-Urgent Crossing Status: Found UCIP Comments: 10/16/2019 Record remains Non-Urgent; crossing has been abandoned. Owner will need to coordinate with CVFPB to remove or abandon crossing per Title 23 requirements. The UCIP inspection was completed with DWR Inspector, L. Dial, and LMA representative, S. Webb. (O. Magana - DWR UCIP)01/09/2014 Pump and pipe appear abandoned and should be done so properly. (W. Wylie - DWR UCIP) FIELD_STRUCT_DESC: *ABANDONED* 8-inch steel irrigation pipe through the levee, 3 feet below the crown. Siphon breaker in 24-inch corrugated metal riser unit on the landside (LS) slope. Pump on the waterside (WS) bank with a butterfly valve. Service pole on the WS berm. (Moitozo Brothers, Inc.). [Additional Reference(s): DWR Levee Log, 2005. USACE Sacramento O&M Manual 506.2, August 1961, (HLM 0.83), Station M281+70, 8-inch pipe, dwg no. CC-4-4-29, Index Sheet 5: page 5, 39 of 64]. FS Date: 10/16/2019 3:59:00 PM

Siphon breaker in 24-inch cmp riser with vent on LS shoulder.

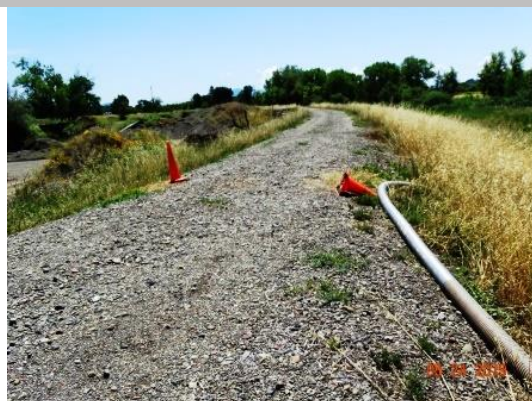
Photo 2 of 2 : FA\_2019\_NA0009\_3\_45\_20190904\_00019.jpg

LM Start	2.10	Rating **	U	Issue No.	45 (cont)	
LM End	2.10	Issue Type +	En	Location *	LS	
Category	Earthen Levee			GPS Latitude/Longitude		
				Start		End
Item	Encroachments			39.162198 °		39.162198 °
				-122.915488 °		-122.915488 °
DWR ID	DWR_NA0009_01_s_2019_45					
Comment Code						
DT : Ditch						
Inspector Comment						
The landowner dug a pit approximately 24' x 12' x 3' within the theoretical levee prism and ran a metal pump hose over the crown.

View looking downstream at a metal hose that ran across the levee crown. Spring 2019

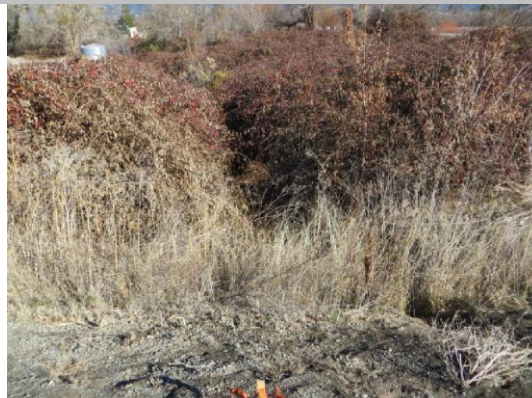
Photo 1 of 3 : UCIP\_FA\_2019\_55702\_49853.jpg

Comment Code					
Inspector Comment					
DS_ID:21240 FS_ID:55702 EP_NO: 11460 Repair Type: Non-Urgent Crossing Status: Found UCIP Comments: 10/16/2019 Record has been updated from No Action Needed to Non-Urgent; need to audit record to confirm owner. Crossing has been internally inspected under the DWR DMP Phase 1 project. Inspection report is still not available. The UCIP inspection was completed with DWR Inspector, L. Dial, and LMA representative, S. Webb. (O. Magana - DWR UCIP) FIELD_STRUCT_DESC: 1 of 2: 36-inch corrugated metal drainage pipe through the levee, 9 feet below the crown. Flap gate on the waterside (WS) end. Concrete headwalls on both ends. (two 36-inch pipes [HLM 2.26] retained under Automatic Board Order (ABO) issued as Permit No. 11460, 1975 - Robert L. and Lavona Gentry). [Additional Reference(s): DWR Levee Log, 2005. USACE Sacramento O&M Manual 506.2, August 1961, (HLM 2.26), Station M206+00, two 36-inch pipes, dwg no. CC-4-4-29, Index Sheet 4: page 4, 38 of 64]. FS Date: 10/16/2019 3:56:00 PM

Pipe and Concrete headwall visible on LS toe.

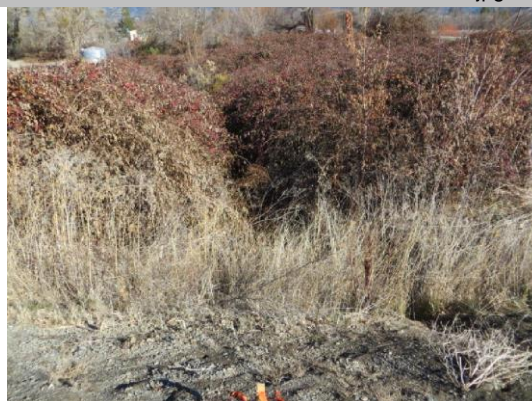
Photo 1 of 3 : UCIP\_FA\_2019\_55703\_49849.jpg

Concrete headwall and pipe visible on LS toe at end of drainage swale.

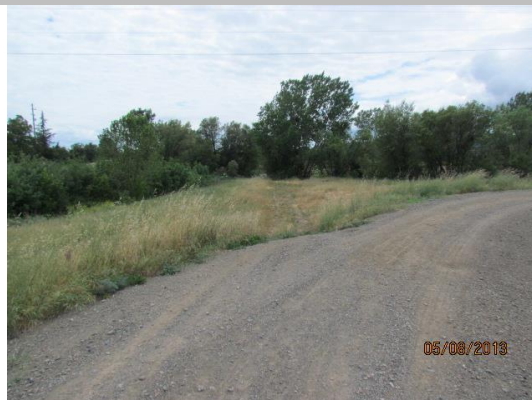
Photo 1 of 1 : FA\_2019\_NA0009\_3\_13\_20190904\_00007.jpg

LM Start	2.29	Rating **	M	Issue No.	13
LM End	2.29	Issue Type +	Ma	Location *	WS
Category	Earthen Levee			GPS Latitude/Longitude	
				Start	End
Item	Slope Stability			39.160285 °	39.160285 °
				-122.913481 °	-122.913481 °
DWR ID	DWR_NA0009_01_s_ 2013_13				
Comment Code					
S3 : Repair the levee slope damaged by vehicle traffic and prevent access where possible.					
Inspector Comment

View of the vehicle erosion along the waterside slope.

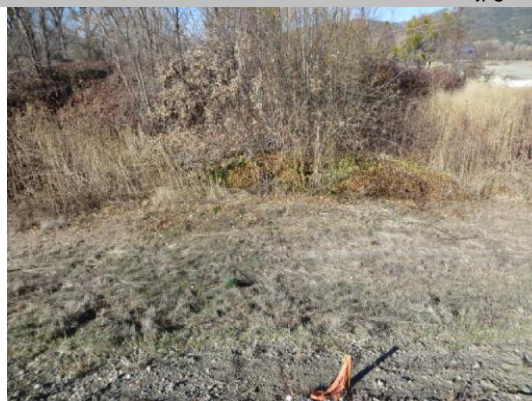
Photo 1 of 3 : UCIP\_FA\_2019\_55705\_49862.jpg

Heavy vegetation at inlet on LS toe.

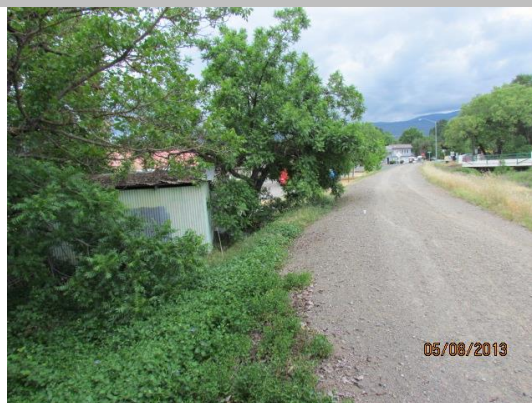
Photo 1 of 1 : FA\_2019\_NA0009\_3\_15\_20190904\_00009.jpg

LM Start	2.38	Rating **	M	Issue No.	15
LM End	2.43	Issue Type +	Ma	Location *	LS
Category	Earthen Levee			GPS Latitude/Longitude	
				Start	End
Item	Trim / Thin Trees			39.161381 °	39.161935 °
				-122.912551 °	-122.911883 °
DWR ID	DWR_NA0009_01_s_2013_15				
Comment Code					
T1 : Trim trees to at least five feet above ground level.					
Inspector Comment					
Trim the trees to at least 5 feet above the ground for visibility, and remove the vegetation from the slope.

Trim the trees up 5 feet to allow visibility. Spring 2013

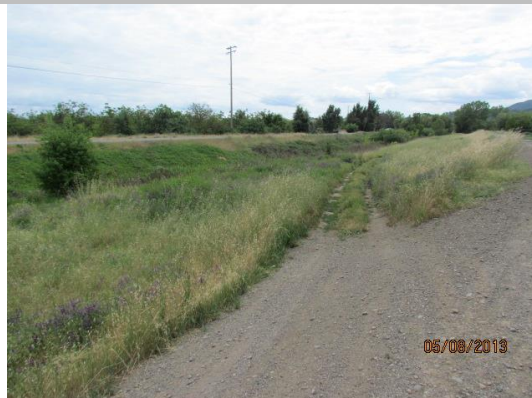
Photo 1 of 1 : FA\_2019\_NA0009\_3\_16\_20190904\_00010.jpg

LM Start	2.40	Rating **	M	Issue No.	16
LM End	2.40	Issue Type +	Ma	Location *	WS
Category	Earthen Levee			GPS Latitude/Longitude	
				Start	End
Item	Slope Stability			39.161601°	39.161601°
				-122.912303°	-122.912303°
DWR ID	DWR_NA0009_01_s_2013_16				
Comment Code					
S3 : Repair the levee slope damaged by vehicle traffic and prevent access where possible.					
Inspector Comment

View of the vehicle erosion along the waterside slope. Spring 2013

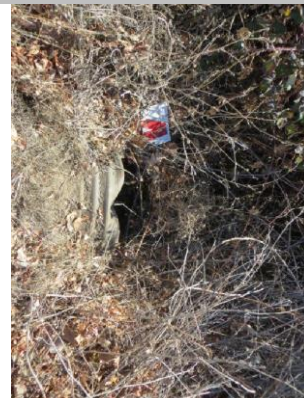
Photo 1 of 3 : UCIP\_FA\_2019\_55707\_50042.jpg

Outlet visible on WS toe.

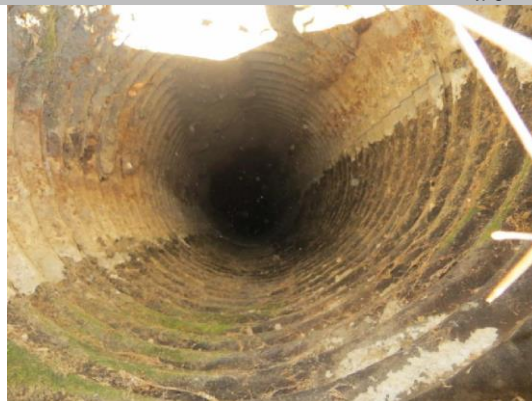
Photo 2 of 3 : UCIP\_FA\_2019\_55707\_50041.jpg

Some rust on inside of CMP pipe at WS toe.

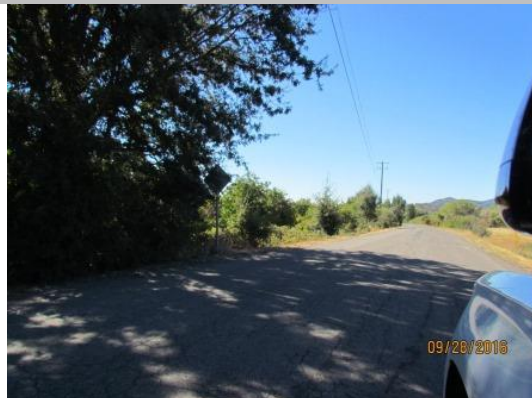
Photo 1 of 1 : FA\_2019\_NA0009\_3\_3\_20190904\_00002.jpg

LM Start	2.48	Rating **	M	Issue No.	3
LM End	2.55	Issue Type +	En	Location *	LS
Category	Earthen Levee			GPS Latitude/Longitude	
				Start	End
Item	Vegetation			39.161615 °	39.160804 °
				-122.911733 °	-122.912536 °
DWR ID	DWR_NA0009_01_s_2012_3				
Comment Code					
V6 : Landscaping					
Inspector Comment					
The landowner needs to thin out thick brush on the other side of the wire fence along the levee toe easement.

View of the vegetation along the landside slope. Fall 2016

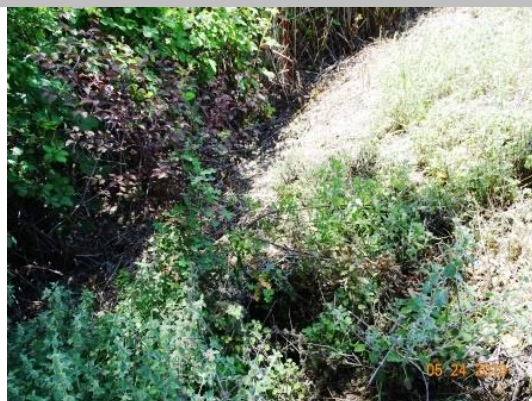
Photo 1 of 1 : FA\_2019\_NA0009\_3\_48\_20190904\_00020.jpg

LM Start	2.49	Rating **	M	Issue No.	48
LM End	2.49	Issue Type +	Ma	Location *	LS
Category	Earthen Levee			GPS Latitude/Longitude	
				Start	End
Item	Animal Control			39.161472 °	39.161472 °
				-122.911822 °	-122.911822 °
DWR ID	DWR_NA0009_01_s_2019_48				
Comment Code					
A3 : No rodents visible, but rodent burrows visible; need to backfill and compact or grout burrows.					
Inspector Comment					
Backfill animal holes on both sides of the levee.

View looking downstream at animal holes on the landside slope. Spring 2019

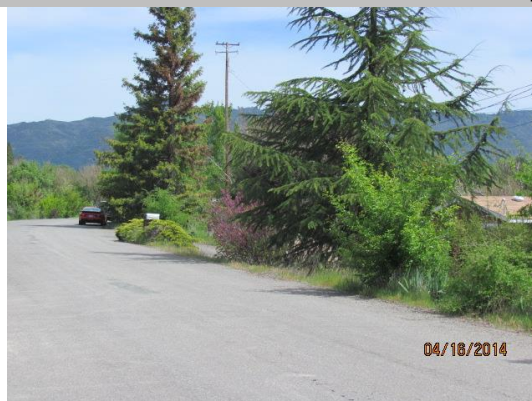
Photo 1 of 1 : FA\_2019\_NA0009\_3\_5\_20190904\_00004.jpg

LM Start	2.58	Rating **	M	Issue No.	5
LM End	2.66	Issue Type +	En	Location *	LS
Category	Earthen Levee			GPS Latitude/Longitude	
				Start	End
Item	Vegetation			39.160443 °	39.159308 °
				-122.912845 °	-122.913417 °
DWR ID	DWR_NA0009_01_s_2012_5				
Comment Code					
V6 : Landscaping					
Inspector Comment

View of the landscape along the landside slope. Spring 2014

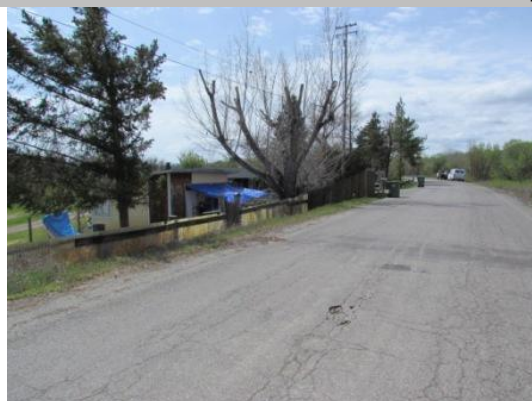
Photo 1 of 1 : FA\_2019\_NA0009\_3\_4\_20190904\_00003.jpg

LM Start	2.58	Rating **	M	Issue No.	4
LM End	2.61	Issue Type +	En	Location *	LS
Category	Earthen Levee			GPS Latitude/Longitude	
				Start	End
Item	Encroachments			39.160398 °	39.160020 °
				-122.912837 °	-122.913186 °
DWR ID	DWR_NA0009_01_s_2012_4				
Comment Code					
FE : Fence					
Inspector Comment

View of the fences at the landside toe.

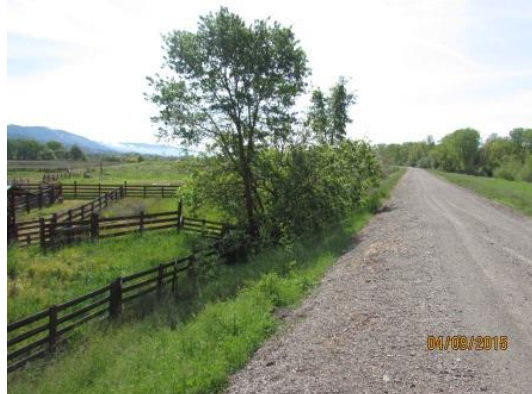
Photo 1 of 1 : FA\_2019\_NA0009\_3\_534\_20190904\_00022.jpg

LM Start	3.26	Rating **	M	Issue No.	534
LM End	3.30	Issue Type +	Ma	Location *	LS
Category	Earthen Levee			GPS Latitude/Longitude	
				Start	End
Item	Trim / Thin Trees			39.150957 °	39.150323 °
				-122.913504 °	-122.913155 °
DWR ID	DWR_NA0009_01_s _ 2015_534				
Comment Code					
T2 : Thin trees to allow visibility of the ground and room to flood fight.					
Inspector Comment

Remove the trees from the landside toe. Spring 2015

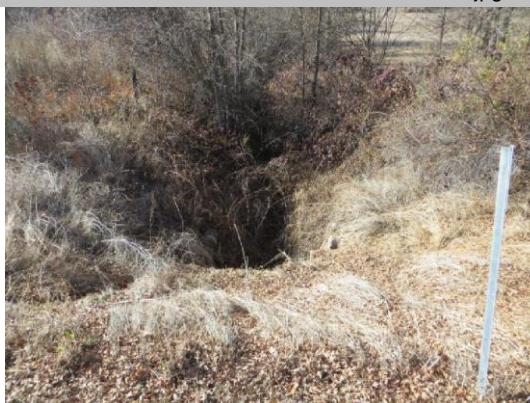
Photo 1 of 3 : UCIP\_FA\_2019\_55713\_50049.jpg

Comment Code						
Inspector Comment						
DS_ID:21201 FS_ID:55713 EP_NO: 11485 Repair Type: Non-Urgent Crossing Status: Found UCIP Comments: 10/23/2019 Record has been updated from No Action Needed to Non-Urgent; need to audit record to confirm owner. Crossing has been internally inspected under the DWR DMP Phase 1 project. Inspection report is still not available. The UCIP inspection was completed with DWR Inspector, L. Dial, and LMA representative, S. Webb. (O. Magana - DWR UCIP) FIELD_STRUCT_DESC: 42-inch corrugated metal drainage pipe through the levee, 8.5 feet below the crown. Flap gate on the waterside (WS). Concrete headwalls on both ends. (42-inch pipe [HLM 0.13] retained under Automatic Board Order (ABO) issued as Permit No. 11485, 1975 - John and Vivian Strickfaden). [Additional Reference(s): DWR Levee Log, 2005. USACE Sacramento O&M Manual 506.2, August 1961, (HLM 0.13), Station M315+75, 42-inch pipe, dwg no. CC-4-4-29, Index Sheet 6: page 6, 40 of 64]. FS Date: 10/23/2019 1:44:00 PM

Pipe and headwall visible at LS toe in drainage swale.

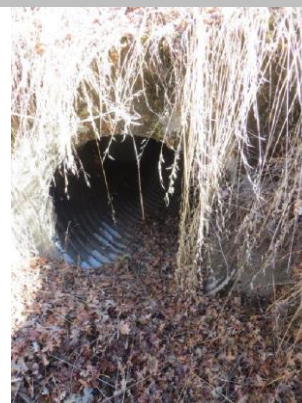
Photo 2 of 3 : UCIP\_FA\_2019\_55713\_50048.jpg

Pipe and headwall visible at LS toe in drainage swale.

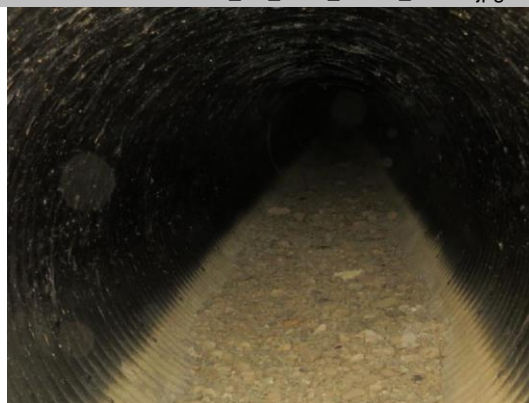
Photo 3 of 3 : UCIP\_FA\_2019\_55713\_50047.jpg

Pipe with some sediment at flowline.

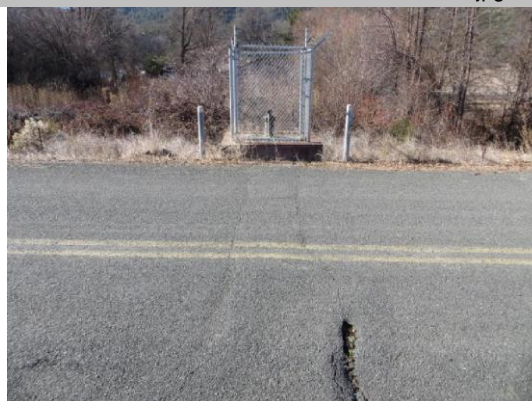
Photo 1 of 3 : UCIP\_FA\_2019\_55714\_50046.jpg

Source of pipe visible at well on LS shoulder. Cut in pavement also visible along pipe alignment.

Comment Code						
Inspector Comment						
DS_ID:21202 FS_ID:55714 EP_NO: 11485 Repair Type: Non-Urgent Crossing Status: Found UCIP Comments: 10/23/2019 Record has been updated from No Action Needed to Non-Urgent; need to audit record to confirm owner. The UCIP inspection was completed with DWR Inspector, L. Dial, and LMA representative, S. Webb. (O. Magana - DWR UCIP) FIELD_STRUCT_DESC: 4-inch steel irrigation pipe through the levee, 3 feet below the crown. Siphon breaker at well on the landside (LS) slope. Irrigation well with cinderblock retaining wall on the LS slope. (Pipe retained under Automatic Board Order (ABO) issued as Permit No. 11485, 1975 - John and Vivian Strickfaden). [Additional Reference(s): DWR Levee Log, 2005. USACE Sacramento O&M Manual 506.2, August 1961, (HLM 0.13), Station M315+50, 4-inch pipe, dwg no. CC-4-4-29, Index Sheet 6: page 6, 40 of 64]. FS Date: 10/23/2019 1:45:00 PM

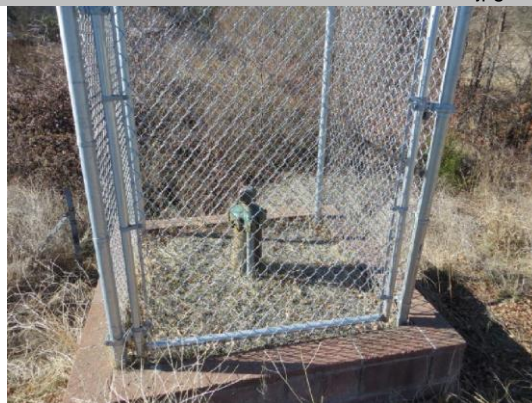
Photo 2 of 3 : UCIP\_FA\_2019\_55714\_50045.jpg

Chainlink fence and cinderblock box around well/pipe on LS shoulder.

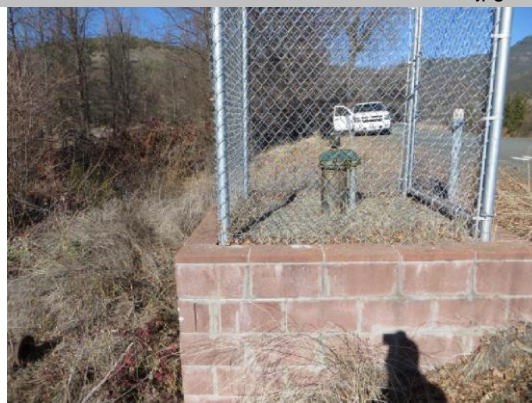
Photo 3 of 3 : UCIP\_FA\_2019\_55714\_50044.jpg

Chainlink fence and cinderblock box around well/pipe on LS shoulder.

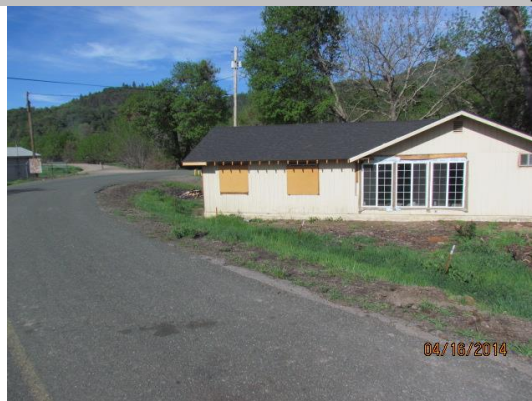
Photo 1 of 1 : FA\_2019\_NA0009\_4\_1\_20190904\_00001.jpg

LM Start	0.20	Rating **	U	Issue No.	1
LM End	0.20	Issue Type +	En	Location *	LS
Category	Earthen Levee			GPS Latitude/Longitude	
				Start	End
Item	Encroachments			39.187039 °	39.187039 °
				-122.908880 °	-122.908880 °
DWR ID	DWR_NA0009_02_s_2016_1				
Comment Code					
BU : Building					
Inspector Comment

View of the building on the landside toe. Spring 2014

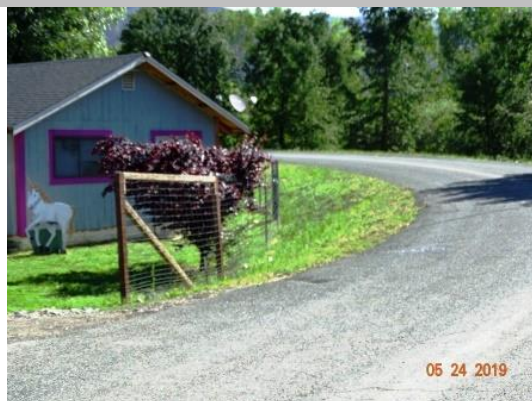
Photo 1 of 1 : FA\_2019\_NA0009\_4\_33\_20190904\_00012.jpg

LM Start	0.21	Rating **	M	Issue No.	33
LM End	0.21	Issue Type +	En	Location *	LS
Category	Earthen Levee			GPS Latitude/Longitude	
				Start	End
Item	Encroachments			39.186940 °	39.186940 °
				-122.909067 °	-122.909067 °
DWR ID	DWR_NA0009_02_s_2019_33				
Comment Code					
FE : Fence					
Inspector Comment					
A metal and wooden fence with mesh is installed at the levee toe.

View looking upstream at a metal and wooden fence at the levee toe.  
Spring 2019

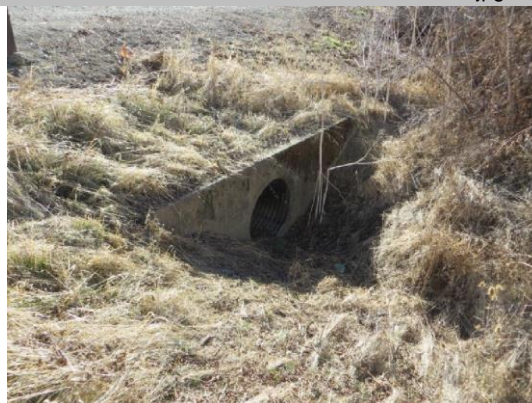
Photo 1 of 3 : UCIP\_FA\_2019\_55717\_50322.jpg

Comment Code					
Inspector Comment					
DS_ID:21204 FS_ID:55717 EP_NO: 11484 Repair Type: Non-Urgent Crossing Status: Found UCIP Comments: 10/23/2019 Record has been updated from No Action Needed to Non-Urgent; need to audit record to confirm owner. Crossing has been internally inspected under the DWR DMP Phase 1 project. Inspection report is still not available. The UCIP inspection was completed with DWR Inspector, L. Dial, and LMA representative, S. Webb. (O. Magana - DWR UCIP) FIELD_STRUCT_DESC: 36-inch corrugated metal drainage pipe through the levee, 6 feet below the crown. Flap gate on the waterside (WS) end. Concrete headwalls on both ends. (36-inch pipe [HLM 0.23] retained under Automatic Board Order (ABO) issued as Permit No. 11484, 1975 - Rodney Snow). [Additional Reference(s): DWR Levee Log, 2005. USACE Sacramento O&M Manual 506.2, August 1961, (HLM 0.23), Station M311+10, 36-inch pipe, dwg no. CC-4-4-29, Index Sheet 6: page 6, 40 of 64]. FS Date: 10/23/2019 1:46:00 PM

Concrete headwall and pipe on LS toe.

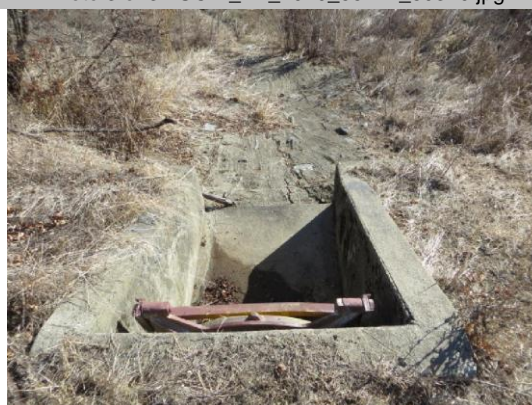
Photo 3 of 3 : UCIP\_FA\_2019\_55717\_50320.jpg

Flapgate and concrete headwall on WS toe.

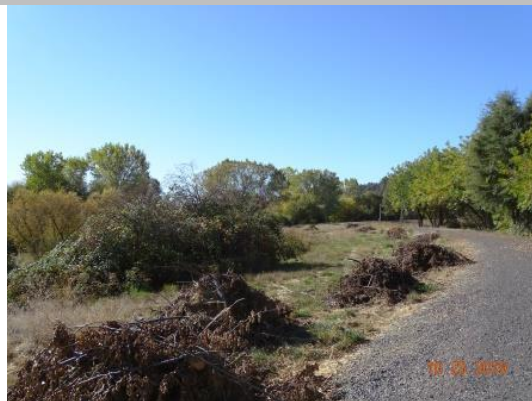
Photo 1 of 1 : FA\_2019\_NA0009\_4\_27\_20191024\_00049.jpg

View of prunings left on the slope. Fall 2019

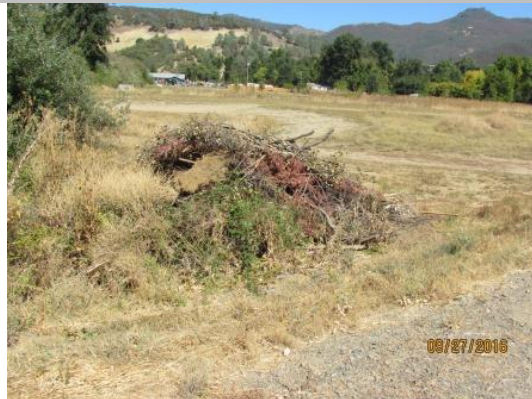
Photo 1 of 1 : FA\_2019\_NA0009\_4\_17\_20190904\_00007.jpg

View of the prunings along the landside toe. Fall 2016

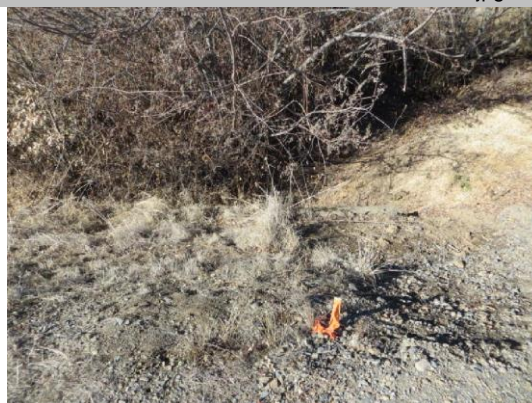
Photo 1 of 3 : UCIP\_FA\_2019\_55718\_50326.jpg

Comment Code					
Inspector Comment					
DS_ID:21206 FS_ID:55718 EP_NO: 11478 Repair Type: Non-Urgent Crossing Status: Found UCIP Comments: 10/23/2019 Record has been updated from No Action Needed to Non-Urgent; need to audit record to confirm owner. Crossing has been internally inspected under the DWR DMP Phase 1 project. Inspection report is still not available. The UCIP inspection was completed with DWR Inspector, L. Dial, and LMA representative, S. Webb. (O. Magana - DWR UCIP) FIELD_STRUCT_DESC: 42-inch corrugated metal drainage pipe through the levee, 7.7 feet below the crown. Flap gate on the waterside (WS) end. Concrete headwalls on both ends. Grouted spillway over revetment on bank. (42-inch pipe [HLM 0.38] retained under Automatic Board Order (ABO) issued as Permit No. 11478, 1975 - William D. and Dorothy L. Allison). [Additional Reference(s): DWR Levee Log, 2005. USACE Sacramento O&M Manual 506.2, August 1961, (HLM 0.38), Station M302+80, 42-inch pipe, dwg no. CC-4-4-29, Index Sheet 6: page 6, 40 of 64]. FS Date: 10/23/2019 1:47:00 PM

Pipe and concrete headwall at LS toe.

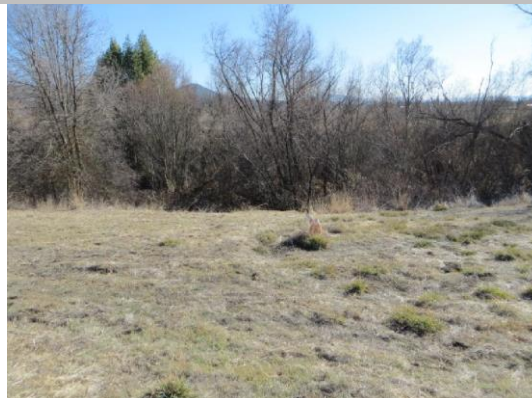
Photo 2 of 3 : UCIP\_FA\_2019\_55718\_50325.jpg

Flapgate and headwall off WS toe at berms edge.

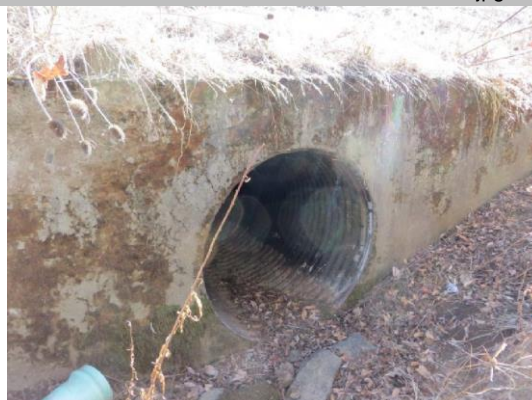
Photo 3 of 3 : UCIP\_FA\_2019\_55718\_50324.jpg

Pipe and concrete headwall at LS toe.

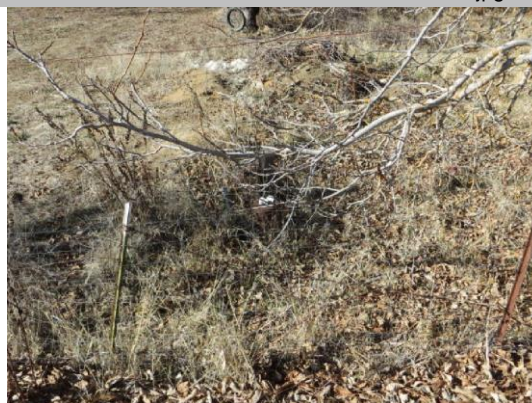
Photo 1 of 3 : UCIP\_FA\_2019\_55719\_50330.jpg

Comment Code					
Inspector Comment					
DS_ID:21207 FS_ID:55719 EP_NO: 7261 Repair Type: Non-Urgent Crossing Status: Indicator Found UCIP Comments: 10/23/2019 Record has been updated from No Action Needed to Non-Urgent; need to audit record to confirm owner. Unable to confirm line through levee. Need updated photos at this crossing. Permit records show pipe installed through levee was a galvanized pipe and not the plastic pipe the owner originally requested in application. The UCIP inspection was completed with DWR Inspector, L. Dial, and LMA representative, S. Webb. (O. Magana - DWR UCIP) FIELD_STRUCT_DESC: 1.5-inch galvanized iron irrigation pipe through the levee, 2.5 feet below the crown. (1.5-inch pipe authorized under Permit No. 7261, 1970 - George Goslowsky). FS Date: 10/23/2019 1:47:00 PM

Well head visible at LS toe.

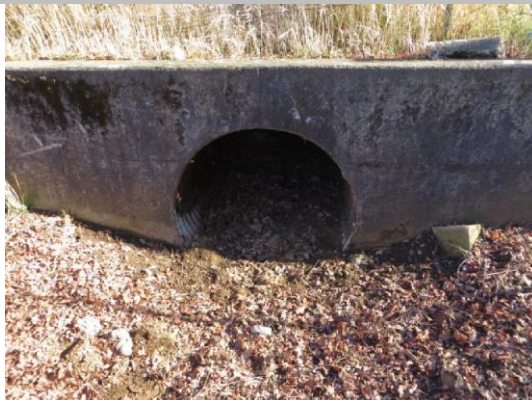
Photo 1 of 3 : UCIP\_FA\_2019\_55723\_50389.jpg

Comment Code					
Inspector Comment					
DS_ID:21208 FS_ID:55723 EP_NO: 11480 Repair Type: Non-Urgent Crossing Status: Found UCIP Comments: 10/23/2019 Record has been updated from No Action Needed to Non-Urgent; need to audit record to confirm owner. Also recommend conducting maintenance at the outlet to repair seepage issue. The seepage issue is about 60 feet from WS toe and poses no threat to the levee. The UCIP inspection was completed with DWR Inspector, L. Dial, and LMA representative, S. Webb. (O. Magana - DWR UCIP) FIELD_STRUCT_DESC: 42-inch corrugated metal drainage pipe through the levee, 7 feet below the crown. Flap gate on the waterside (WS) end. Concrete headwalls on both ends. (42-inch pipe [HLM 0.47] retained under Automatic Board Order (ABO) issued as Permit No. 11480, 1975 - Jose G. and Dora Moto). [Additional Reference(s): DWR Levee Log, 2005. USACE Sacramento O&M Manual 506.2, August 1961, (HLM 0.47), Station M299+30, 42-inch pipe, dwg no. CC-4-4-29, Index Sheet 6: page 6, 40 of 64]. FS Date: 10/23/2019 1:48:00 PM

Concrete headwall on LS toe.

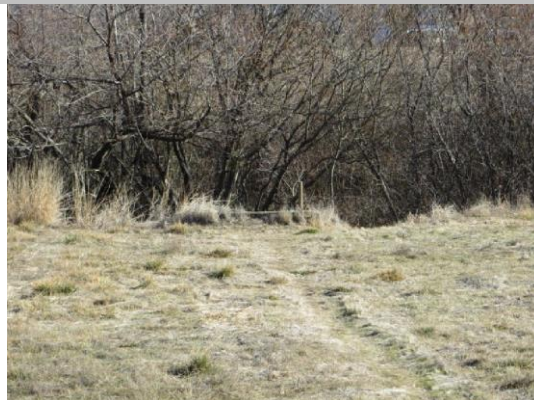
Photo 3 of 3 : UCIP\_FA\_2019\_55723\_50387.jpg

Concrete headwall and flapgate visible on waterside berm

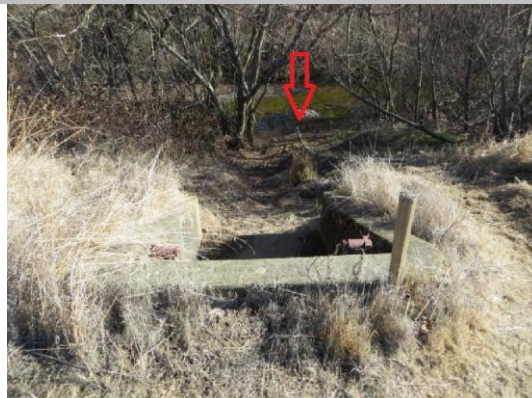
Photo 1 of 3 : UCIP\_FA\_2019\_55720\_51182.jpg

Comment Code						
Inspector Comment						
DS_ID:24761						
FS_ID:55720						
EP_NO: N/A						
Repair Type: Non-Urgent						
Crossing Status: Found						
UCIP Comments: 10/23/2019 Record remains Non-Urgent; no permit has been found authorizing encroachment. Need updated photos of levee crown and WS. The UCIP inspection was completed with DWR Inspector, L. Dial, and LMA representative, S. Webb. (O. Magana - DWR UCIP)01/14/2014 No Permit identified for crossing. (W. Wylie - DWR UCIP)						
FIELD_STRUCT_DESC: 1.5-inch high-density polyethylene irrigation pipe through the levee, 2.5 feet below the crown. Pipe visible on the waterside (WS) berm and slope. Pump house on the LS toe.						
FS Date: 10/23/2019 1:49:00 PM

Pipe visible just downstream from stormdrain.

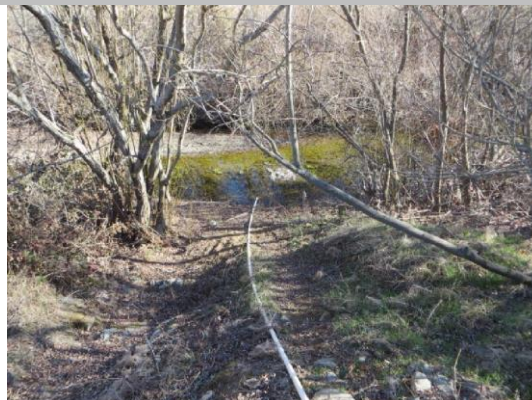
Photo 2 of 3 : UCIP\_FA\_2019\_55720\_51181.jpg

Pipe visible just downstream from stormdrain.

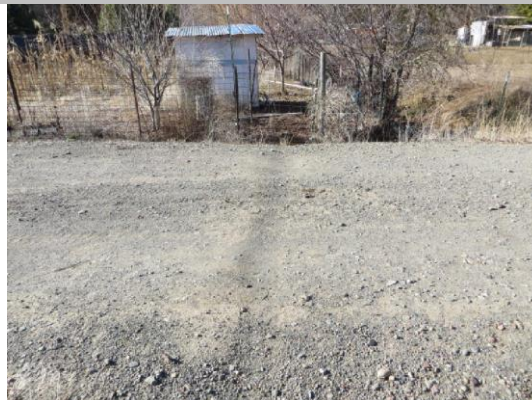
Photo 3 of 3 : UCIP\_FA\_2019\_55720\_51180.jpg

Comment Code						
Inspector Comment						
DS_ID:24761						
FS_ID:55720						
EP_NO: N/A						
Repair Type: Non-Urgent						
Crossing Status: Found						
UCIP Comments: 10/23/2019 Record remains Non-Urgent; no permit has been found authorizing encroachment. Need updated photos of levee crown and WS. The UCIP inspection was completed with DWR Inspector, L. Dial, and LMA representative, S. Webb. (O. Magana - DWR UCIP)01/14/2014 No Permit identified for crossing. (W. Wylie - DWR UCIP)						
FIELD_STRUCT_DESC: 1.5-inch high-density polyethylene irrigation pipe through the levee, 2.5 feet below the crown. Pipe visible on the waterside (WS) berm and slope. Pump house on the LS toe.						
FS Date: 10/23/2019 1:49:00 PM

cut across levee crown visible along pipe alignment.

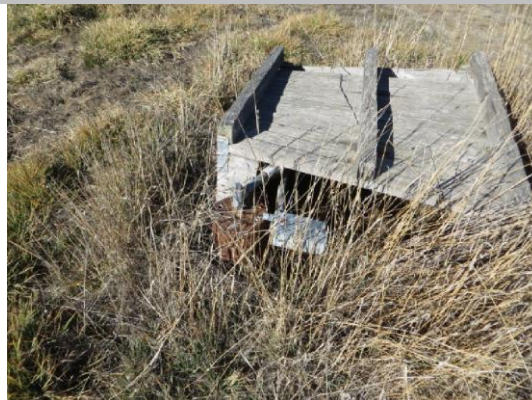
Photo 1 of 3 : UCIP\_FA\_2019\_55729\_50401.jpg

Comment Code						
Inspector Comment						
DS_ID:21249 FS_ID:55729 EP_NO: 8513 Repair Type: Non-Urgent Crossing Status: Found UCIP Comments: 10/23/2019 Record has been updated from No Action Needed to Non-Urgent; recommend auditing permit to find current owner and identify if encroachment is still in use. Encroachment appears to be abandoned. If crossing is no longer in use, the owner will need to coordinate with the CVFPB to properly remove or abandon per Title 23 requirements. The UCIP inspection was completed with DWR Inspector, L. Dial, and LMA representative, S. Webb. (O. Magana - DWR UCIP) FIELD_STRUCT_DESC: 2 of 2: 0.75-inch steel electrical conduit through the levee, 2 feet below the levee. Steel cutoff wall around conduit at center of levee. Well with 8-inch casing on the waterside (WS) slope. (well located on the levee berm, water pipe, and electrical conduit authorized under Permit No. 8513, 1972 - James A. Fisher). [Additional Reference(s): DWR Levee Log, 2005]. FS Date: 10/23/2019 1:49:00 PM

Electrical conduit visible at pump/wellhead on WS berm.

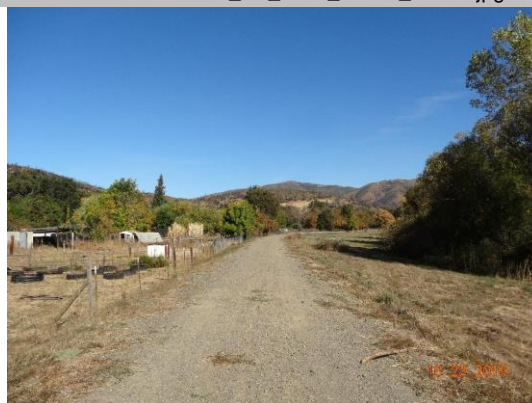
Photo 2 of 3 : UCIP\_FA\_2019\_55729\_82581.jpg

Overview of levee crown looking u/s towards pipe crossing.

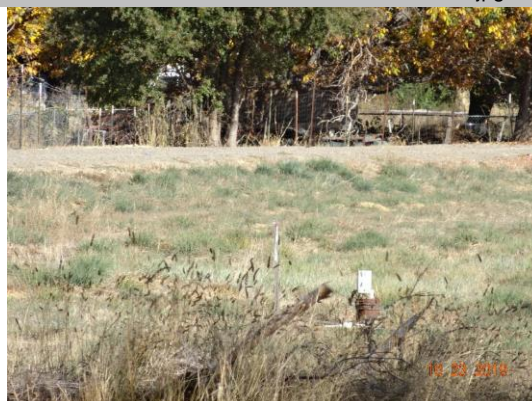
Photo 3 of 3 : UCIP\_FA\_2019\_55729\_82582.jpg

Comment Code						
Inspector Comment						
DS_ID:21249 FS_ID:55729 EP_NO: 8513 Repair Type: Non-Urgent Crossing Status: Found UCIP Comments: 10/23/2019 Record has been updated from No Action Needed to Non-Urgent; recommend auditing permit to find current owner and identify if encroachment is still in use. Encroachment appears to be abandoned. If crossing is no longer in use, the owner will need to coordinate with the CVFPB to properly remove or abandon per Title 23 requirements. The UCIP inspection was completed with DWR Inspector, L. Dial, and LMA representative, S. Webb. (O. Magana - DWR UCIP) FIELD_STRUCT_DESC: 2 of 2: 0.75-inch steel electrical conduit through the levee, 2 feet below the levee. Steel cutoff wall around conduit at center of levee. Well with 8-inch casing on the waterside (WS) slope. (well located on the levee berm, water pipe, and electrical conduit authorized under Permit No. 8513, 1972 - James A. Fisher). [Additional Reference(s): DWR Levee Log, 2005]. FS Date: 10/23/2019 1:49:00 PM

WS view: well and other appurtenances located on the WS levee berm.

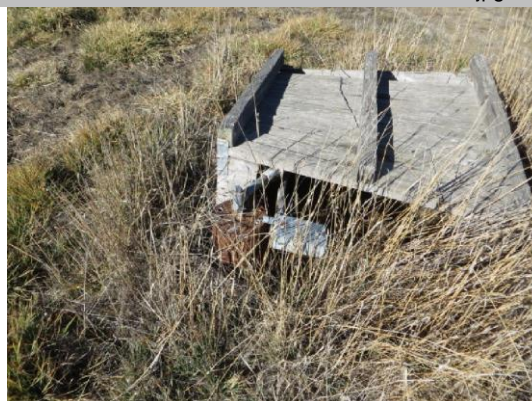
Photo 1 of 3 : UCIP\_FA\_2019\_55728\_50393.jpg

Comment Code						
Inspector Comment						
DS_ID:21209 FS_ID:55728 EP_NO: 8513 Repair Type: Non-Urgent Crossing Status: Found UCIP Comments: 10/23/2019 Record remains Non-Urgent; recommend auditing permit to find current owner and identify if encroachment is still in use. Encroachment appears to be abandoned. If crossing is no longer in use, the owner will need to coordinate with the CVFPB to properly remove or abandon per Title 23 requirements. The UCIP inspection was completed with DWR Inspector, L. Dial, and LMA representative, S. Webb. (O. Magana - DWR UCIP)09/06/2018 Pump no longer in operation. Downgraded from Urgent to Non-Urgent (D. Sanoski - DWR UCIP).11/30/2016 Pipe not in use per LMA representative, Scott Webb. DWR Fall inspection 2016 indicated depression along pipe alignment. According to LMA representative the new property owner is Tracy Joe Hill. Need to contact owner. New owner will need to coordinate with CVFPB regarding permit name change and to address depression noted in the 2016 DWR Fall Inspection . (O. Magana - DWR UCIP)01/14/2014 Appears pipe is leaking on WS toe of Levee at mud pit. (W. Wylie - DWR UCIP) FIELD_STRUCT_DESC: 1 of 2: 1.25-inch steel groundwater pipe through the levee, 2 feet below the levee. Steel cutoff wall around pipe at center of levee. Well with 8-inch casing on waterside (WS) slope. (1.25-inch water pipe and 0.75-inch electrical conduit authorized under Permit No. 8513, 1974 - Fisher) FS Date: 10/23/2019 1:07:00 PM

Pump and pipe visible at wooden box on WS berm.

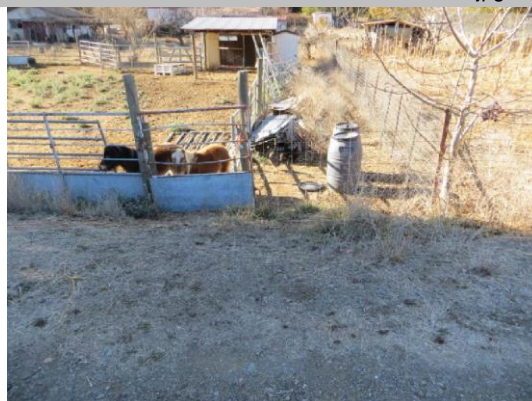
Photo 3 of 3 : UCIP\_FA\_2019\_55728\_50391.jpg

Comment Code						
Inspector Comment						
DS_ID:21209 FS_ID:55728 EP_NO: 8513 Repair Type: Non-Urgent Crossing Status: Found UCIP Comments: 10/23/2019 Record remains Non-Urgent; recommend auditing permit to find current owner and identify if encroachment is still in use. Encroachment appears to be abandoned. If crossing is no longer in use, the owner will need to coordinate with the CVFPB to properly remove or abandon per Title 23 requirements. The UCIP inspection was completed with DWR Inspector, L. Dial, and LMA representative, S. Webb. (O. Magana - DWR UCIP)09/06/2018 Pump no longer in operation. Downgraded from Urgent to Non-Urgent (D. Sanoski - DWR UCIP).11/30/2016 Pipe not in use per LMA representative, Scott Webb. DWR Fall inspection 2016 indicated depression along pipe alignment. According to LMA representative the new property owner is Tracy Joe Hill. Need to contact owner. New owner will need to coordinate with CVFPB regarding permit name change and to address depression noted in the 2016 DWR Fall Inspection . (O. Magana - DWR UCIP)01/14/2014 Appears pipe is leaking on WS toe of Levee at mud pit. (W. Wylie - DWR UCIP) FIELD_STRUCT_DESC: 1 of 2: 1.25-inch steel groundwater pipe through the levee, 2 feet below the levee. Steel cutoff wall around pipe at center of levee. Well with 8-inch casing on waterside (WS) slope. (1.25-inch water pipe and 0.75-inch electrical conduit authorized under Permit No. 8513, 1974 - Fisher) FS Date: 10/23/2019 1:07:00 PM

Valves visible just off LS toe.

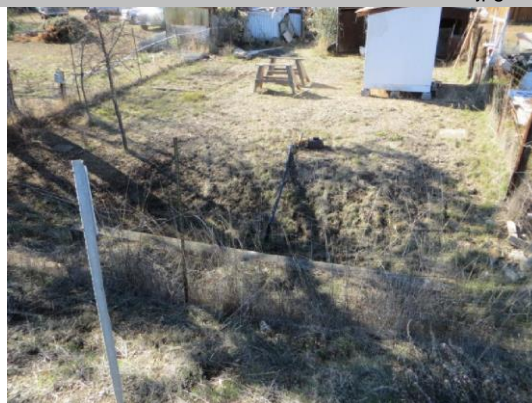
Photo 1 of 3 : UCIP\_FA\_2019\_55730\_50411.jpg

Comment Code					
Inspector Comment					
DS_ID:21210 FS_ID:55730 EP_NO: 11482 Repair Type: Non-Urgent Crossing Status: Found UCIP Comments: 10/23/2019 Record remains Non-Urgent; need to audit record to confirm owner. Property owner will also need to address access issue due to fence installed on the LS slope. Crossing has been internally inspected under the DWR DMP Phase 1 project. Inspection report is still not available. The UCIP inspection was completed with DWR Inspector, L. Dial, and LMA representative, S. Webb. (O. Magana - DWR UCIP)01/14/2014 Fence on LS slope creates access issue. (W. Wylie - DWR UCIP) FIELD_STRUCT_DESC: 36-inch corrugated metal drainage pipe through the levee, 9 feet below the crown. Flap gate on the waterside (WS) end. Concrete headwalls on both ends. (36-inch pipe [HLM 0.54] retained under ABO No. 11482, 1975 - George R. and Gladys Schneider). [Additional Reference(s): DWR Levee Log, 2005. USACE Sacramento O&M Manual 506.2, August 1961, (HLM 0.54), Station M294+00, 36-inch pipe, dwg no. CC-4-4-29, Index Sheet 6: page 6, 40 of 64]. FS Date: 10/23/2019 1:50:00 PM

Concrete headwall on LS toe.

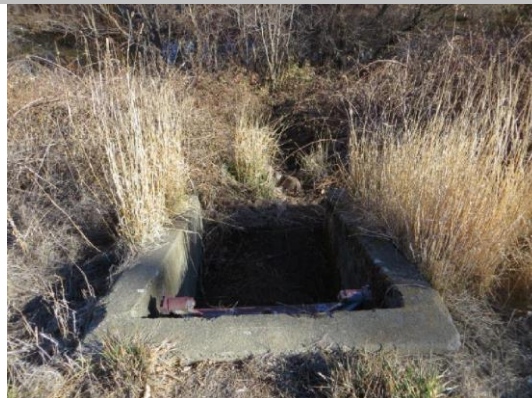
Photo 2 of 3 : UCIP\_FA\_2019\_55730\_50410.jpg

Comment Code						
Inspector Comment						
DS_ID:21210 FS_ID:55730 EP_NO: 11482 Repair Type: Non-Urgent Crossing Status: Found UCIP Comments: 10/23/2019 Record remains Non-Urgent; need to audit record to confirm owner. Property owner will also need to address access issue due to fence installed on the LS slope. Crossing has been internally inspected under the DWR DMP Phase 1 project. Inspection report is still not available. The UCIP inspection was completed with DWR Inspector, L. Dial, and LMA representative, S. Webb. (O. Magana - DWR UCIP)01/14/2014 Fence on LS slope creates access issue. (W. Wylie - DWR UCIP) FIELD_STRUCT_DESC: 36-inch corrugated metal drainage pipe through the levee, 9 feet below the crown. Flap gate on the waterside (WS) end. Concrete headwalls on both ends. (36-inch pipe [HLM 0.54] retained under ABO No. 11482, 1975 - George R. and Gladys Schneider). [Additional Reference(s): DWR Levee Log, 2005. USACE Sacramento O&M Manual 506.2, August 1961, (HLM 0.54), Station M294+00, 36-inch pipe, dwg no. CC-4-4-29, Index Sheet 6: page 6, 40 of 64]. FS Date: 10/23/2019 1:50:00 PM

Flapgate and concrete headwall on WS berm.

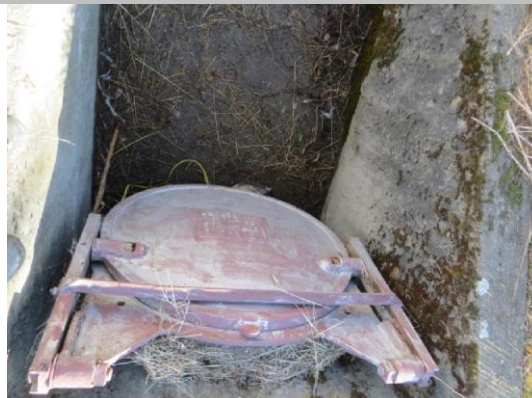
Photo 3 of 3 : UCIP\_FA\_2019\_55730\_50409.jpg

Flapgate and concrete headwall on WS berm.

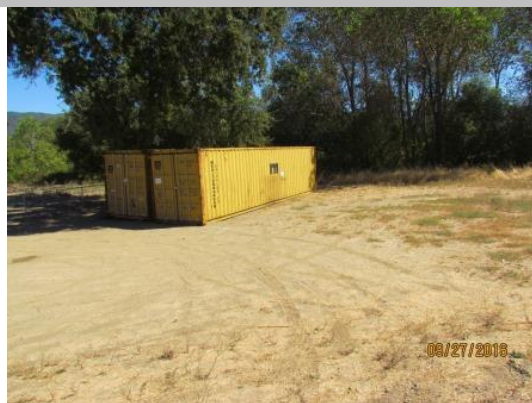
Photo 1 of 1 : FA\_2019\_NA0009\_4\_25\_20190904\_00009.jpg

LM Start	0.96	Rating **	M	Issue No.	25
LM End	0.96	Issue Type +	En	Location *	WS
Category	Earthen Levee			GPS Latitude/Longitude	
				Start	End
Item	Encroachments			39.177249 °	39.177249 °
				-122.913619 °	-122.913619 °
DWR ID	DWR_NA0009_02_f_2016_25				
Comment Code					
BU : Building					
Inspector Comment					
Two 40' shipping containers in the floodway need to be removed.

View of the shipping container in the floodway. Fall 2016

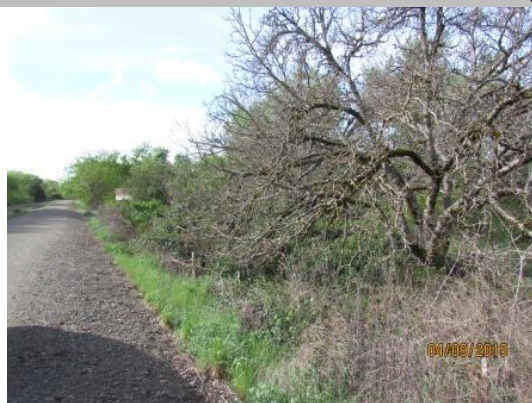
Photo 1 of 1 : FA\_2019\_NA0009\_4\_7\_20190904\_00004.jpg

LM Start	0.97	Rating **	M	Issue No.	7
LM End	0.98	Issue Type +	Ma	Location *	LS
Category	Earthen Levee			GPS Latitude/Longitude	
				Start	End
Item	Vegetation			39.177218 °	39.176992 °
				-122.913673 °	-122.913642 °
DWR ID	DWR_NA0009_02_s_2012_7				
Comment Code					
V2 : Remove the wild growth other than native grasses from the levee slopes.					
Inspector Comment

View of the vegetation at the landside toe.

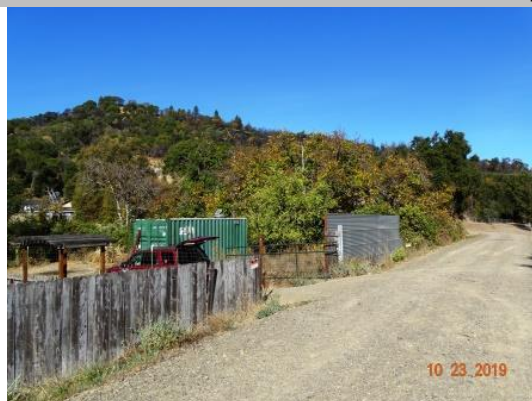
Photo 1 of 1 : FA\_2019\_NA0009\_4\_2\_20191024\_00050.jpg

LM Start	0.99	Rating **	U	Issue No.	2
LM End	0.99	Issue Type +	En	Location *	LS
Category	Earthen Levee			GPS Latitude/Longitude	
				Start	End
Item	Encroachments			39.176815 °	39.176815 °
				-122.913540 °	-122.913540 °
DWR ID	DWR_NA0009_02_s_2012_2				
Comment Code					
FE : Fence					
Inspector Comment					
An unpermitted fence runs along the landside toe.

View of wooden and sheet metal fence along the levee toe. Fall 2019

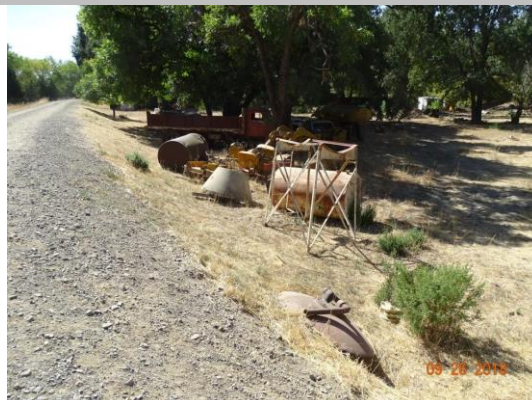
Photo 1 of 1 : FA\_2019\_NA0009\_4\_31\_20190904\_00011.jpg

LM Start	1.05	Rating **	M	Issue No.	31
LM End	1.06	Issue Type +	En	Location *	LS
Category	Earthen Levee			GPS Latitude/Longitude	
				Start	End
Item	Encroachments			39.176008 °	39.175810 °
				-122.913482 °	-122.913367 °
DWR ID	DWR_NA0009_02_f_2018_31				
Comment Code					
EQ : Equipment					
Inspector Comment					
Move equipment to at least 10' away from the levee toe.

View of equipment along the landside toe. Fall 2018

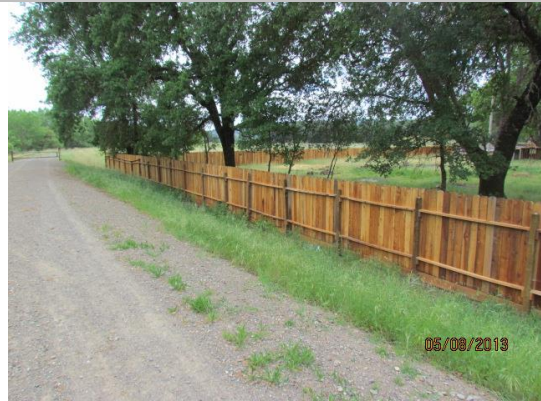
Photo 1 of 1 : FA\_2019\_NA0009\_4\_10\_20190904\_00006.jpg

LM Start	1.09	Rating **	U	Issue No.	10
LM End	1.11	Issue Type +	En	Location *	LS
Category	Earthen Levee			GPS Latitude/Longitude	
				Start	End
Item	Encroachments			39.175460°	39.175075°
				-122.913400°	-122.913392°
DWR ID	DWR_NA0009_02_s_2013_10				
Comment Code					
FE : Fence					
Inspector Comment

View of the unauthorized fence along the landside toe. Spring 2013

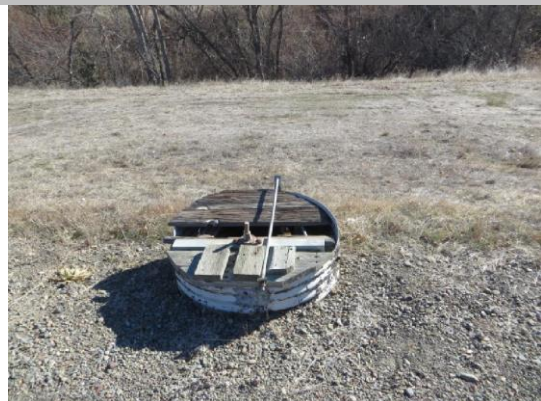
Photo 1 of 3 : UCIP\_FA\_2019\_55741\_51214.jpg

Comment Code					
Inspector Comment					
DS_ID:21212 FS_ID:55741 EP_NO: 11483 Repair Type: Non-Urgent Crossing Status: Found UCIP Comments: 10/23/2019 Record remains Non-Urgent, crossing appears abandoned; need to audit record to confirm owner. Crossing has been internally inspected under the DWR DMP Phase 1 project. Inspection report is still not available. The UCIP inspection was completed with DWR Inspector, L. Dial, and LMA representative, S. Webb. (O. Magana - DWR UCIP)01/22/2014 Pipe appears abandoned and if so, should be done so properly. Debris blocking flap gate at outlet. (W. Wylie - DWR UCIP) FIELD_STRUCT_DESC: *ABANDONED* 30-inch corrugated metal drainage pipe through the levee, 17.8 feet below the crown. Slide gate in 44-inch corrugated metal riser unit on the waterside (WS) slope. Flap gate on the WS end at concrete headwall. 6-foot by 8-foot concrete sump at the landside (LS) toe. (30-inch pipe [HLM 1.22] retained under Automatic Board Order (ABO) issued as Permit No. 11483, 1975 - Edward M. and Mildred E. Seely). [Additional Reference(s): DWR Levee Log, 2005. USACE Sacramento O&M Manual 506.2, August 1961, (HLM 1.22)]. FS Date: 10/23/2019 1:16:00 PM

Slide gate in 44-inch CMP riser on WS shoulder.

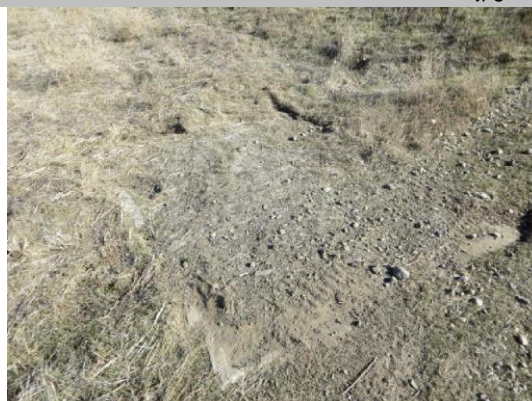
Photo 2 of 3 : UCIP\_FA\_2019\_55741\_51213.jpg

6'X8' concrete sump filled in with soil, visible at LS toe.

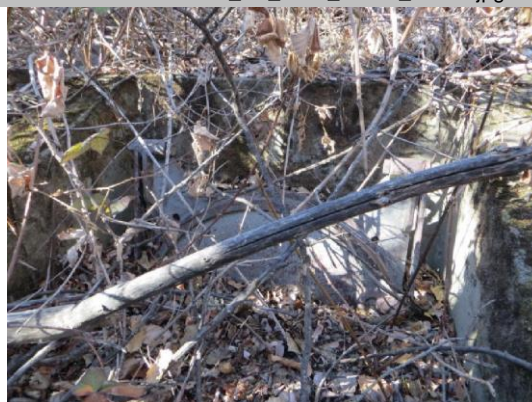
Photo 3 of 3 : UCIP\_FA\_2019\_55741\_51215.jpg

Flapgate and concrete headwall visible off WS berm.

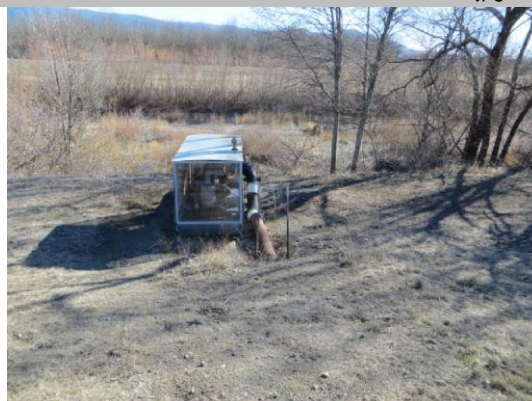
Photo 1 of 3 : UCIP\_FA\_2019\_55742\_51242.jpg

Comment Code						
Inspector Comment						
DS_ID:21213 FS_ID:55742 EP_NO: 16177 Repair Type: Non-Urgent Crossing Status: Found UCIP Comments: 10/23/2019 Record has been updated from No Action Needed to Non-Urgent, pipe appears to be abandoned; need to audit record to confirm owner. Pipe owner has removed pump and pipe section from the WS. The UCIP inspection was completed with DWR Inspector, L. Dial, and LMA representative, S. Webb. (O. Magana - DWR UCIP) FIELD_STRUCT_DESC: 10-inch coated steel irrigation pipe through the levee, 2 feet below the crown. Siphon breaker on apex of pipe at the landside (LS) shoulder. Exposed filter on LS slope. Seasonal pump on the waterside (WS) slope. (12-inch pipe authorized under Permit No. 16177, 1994 - Edward Seely). [Additional Reference(s): DWR Levee Log, 2005]. FS Date: 10/23/2019 1:17:00 PM

Pump and pipe visible on WS toe.

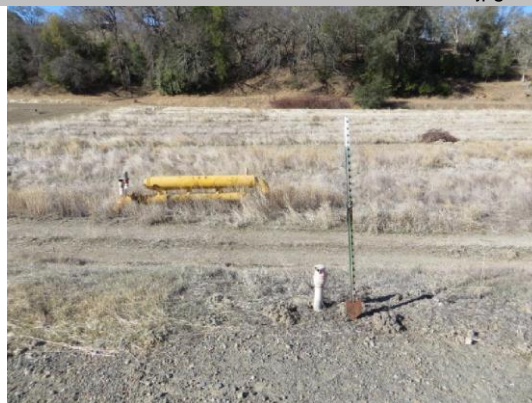
Photo 2 of 3 : UCIP\_FA\_2019\_55742\_51241.jpg

Vent on LS shoulder with filter plant visible at LS toe in background.

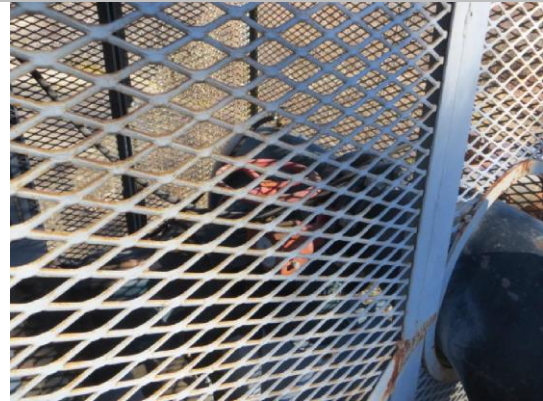
Photo 3 of 3 : UCIP\_FA\_2019\_55742\_51240.jpg

Gate valve visible at portable pump on WS toe.
